## Report about the quality of drinking water in Al Teneyh village camp

### • Al Teneyh village camp

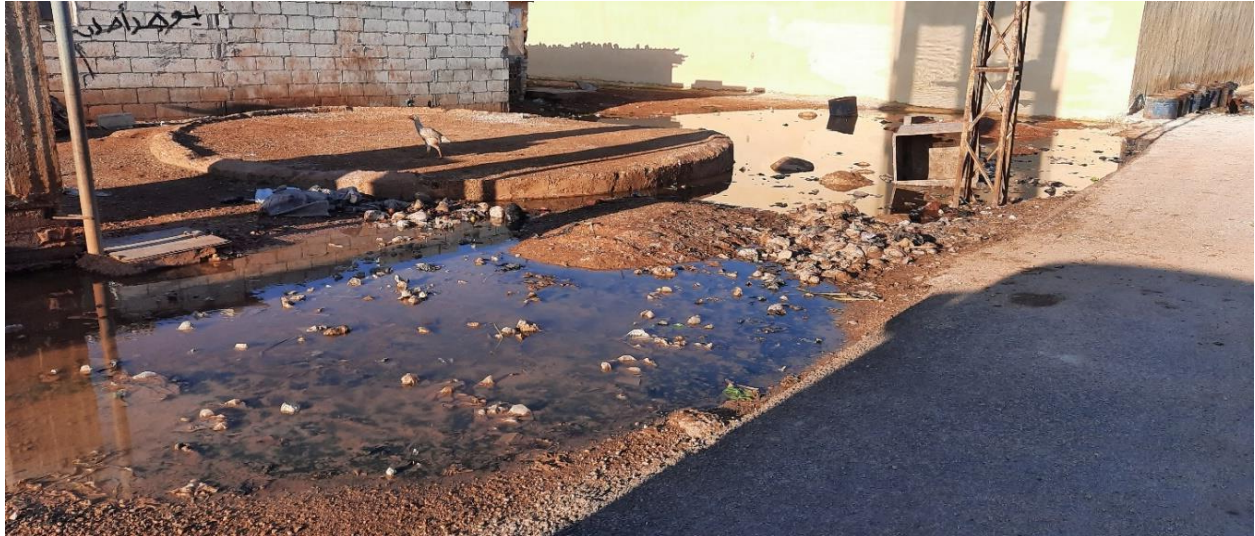
- The WASH team at ACU was informed by the camp administration of the presence of impurities in the drinking water that has an odor as well, thus there is a possibility of wastewater leakage into the

source of the drinking water that feeds the village as a result of the formation of a sump of wastewater, as shown in the picture below

- ACU WASH team has taken several steps to reduce the risk of spreading diseases and solve the problem as follows:
  - o Inform the responsible authorities in the camp to stop pumping water from the polluted well immediately and find an alternative drinking water source.
  - o Carrying out a technical study and preparing the report (details below).
  - o Sharing the technical study results with the WASH Cluster to advocate and encourage cluster members for rapid intervention.

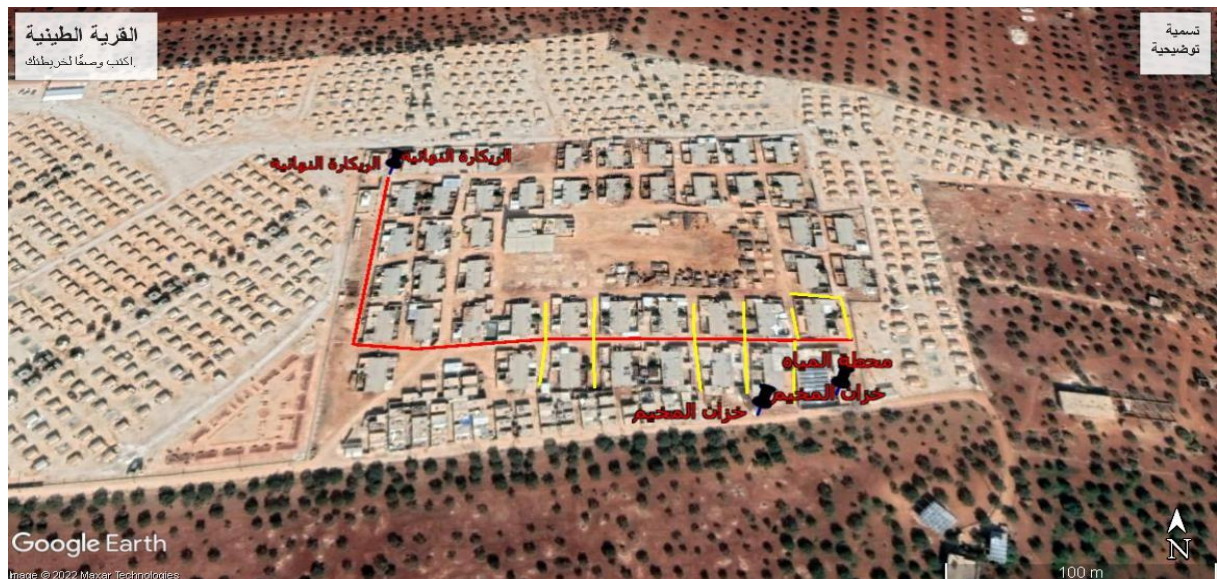
- By re-inspecting the well site and surroundings, we have noticed the following:
  1. There is a low land (semi-hollow) close to the well where rainwater collects plus some people used to throw garbage in it and this led to the creation of a garbage and wastewater pool.

2. There are inspection rooms close to the well which are built of a normal block without any plastering, reinforced or normal concrete, and are linked to the main pipe through a concrete pipe of 200 m. They are designed for serving four houses through a joint PVC pipe of 4 inches which is damaged due to being close to the earth's surface.

3. We found that about 50 m of the main drainage pipe in the camp is with a reverse slope and this impairs and impacts the drainage of wastewater clearly, where the problem is that the slope of the main pipe is incorrect, in addition to the low number of manholes/inspection rooms along the main drainage pipe, thus, this problem can be solved by replacing the main drainage pipe of 350 meters using a concrete pipe of 300 mm instead of the old one with the same length and correct slop and installing 7 manholes/inspection rooms along the pipe considering that the depth of the last manhole ground is about 185 cm.

4. Also, the 22 sub-manholes/inspection rooms and the sub pipis that link these sub-manholes with the main pipe must be replaced, considering that the length of the sub-pipe is about 22 m, therefore the total length to be replaced is 660 meters.

5. Opening and cleaning the other lines in the network by a pulsator and pumping the water inside the pipes
