Date: 25.04.2022

## Water Quality Report in Marma Elhajar village

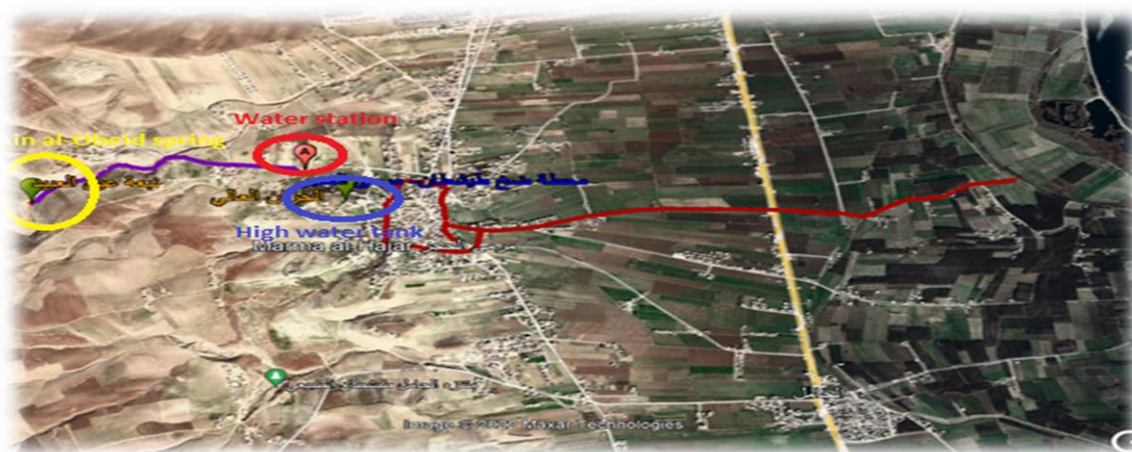
- There are agricultural lands surrounding the spring that is being cultivated with various crops. These agricultural lands are about 500 meters away from the spring and they are being fertilized, but the fertilization process is very poor due to the high costs of fertilizers.
- The figure below shows the location of the spring, water pumping, and the high water tank in addition to the path of the pumping line.

- The red line is the wastewater line
- As for the violet color, it is the line connecting the spring and the pumping station
