The date of the report: November 22, 2022

## INVESTIGATION REPORT ABOUT THE SPREAD OF CHOLERA IN HARIM CITY

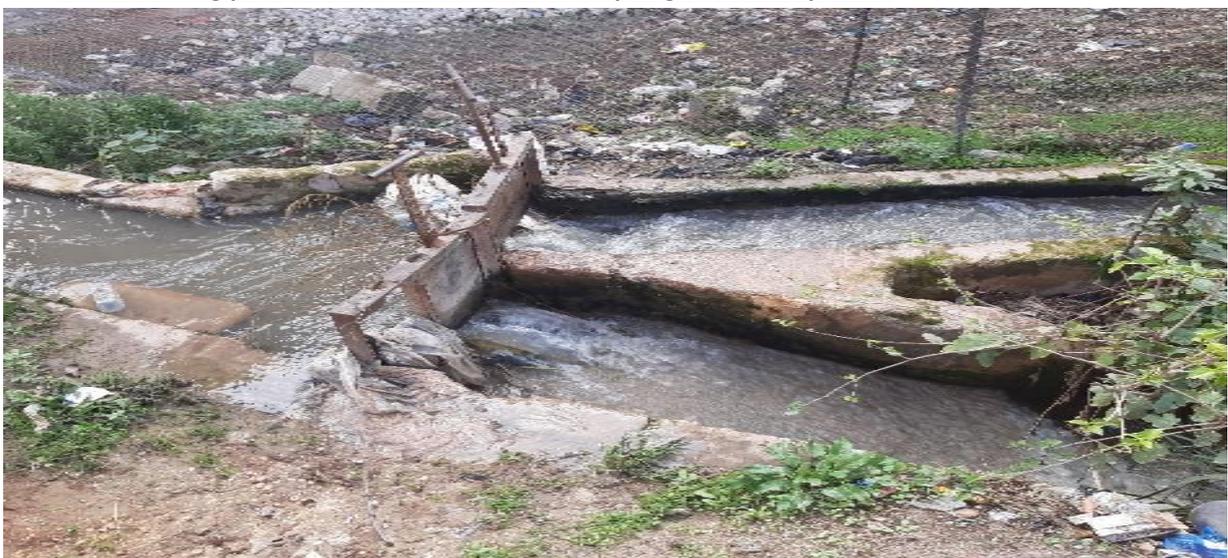
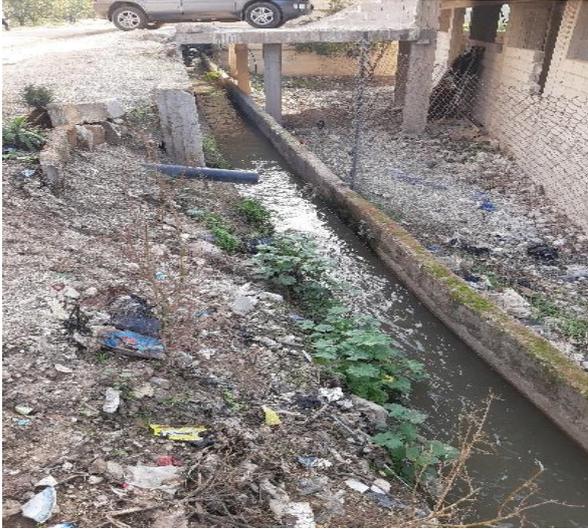
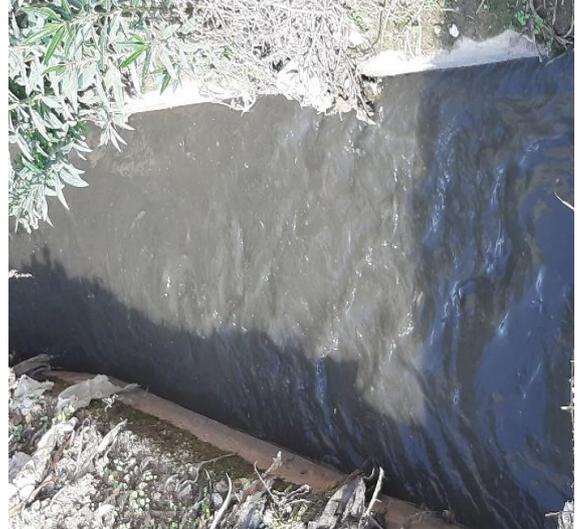
##### The following pictures show the track of the spring in several places.

The track of the **spring** was studied as well, as it was found that many household drainage lines along the track of the **spring** flow into it thus polluting the water of the **spring** in a large and clear way, as the water appears in some places like or similar to wastewater, knowing that the water of the **spring** that pours into agricultural lands as mentioned previously is used to irrigate crops of all kinds, such as vegetables and fruit trees .

2. The local authorities must carry out strict measures in this regard and raise awareness among the local population and work with other organizations and actors to find proper solutions to the sewage network problems in both Al-Nabaa and Al-Marjah neighborhoods which contaminate the spring, in addition to preventing the discharge of wastewater into the track of the spring.

3. Carrying out complete and effective maintenance for the sewage system in the city, especially the neighborhoods near the spring to stop the leakage from the sewage pipes, which at the same time leads to the contamination of the freshwater coming out of the spring. Also, effective maintenance must be carried out for the spring channels, especially those underground, which were previously damaged, in addition to working to cover the exposed parts and stop the entering wastewater into the channels.

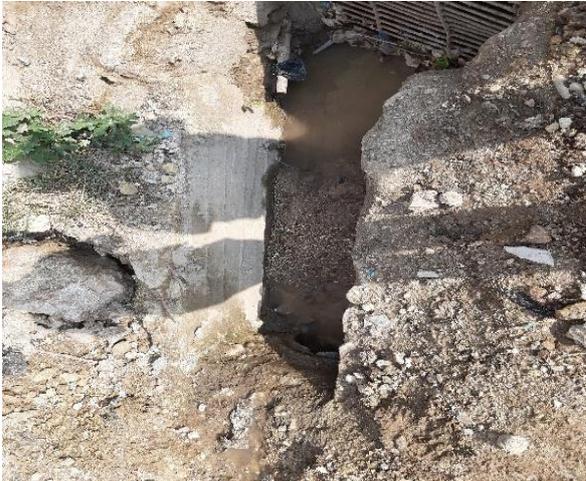
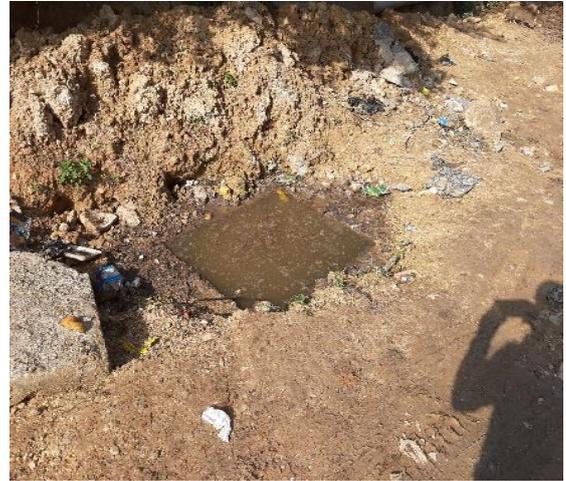
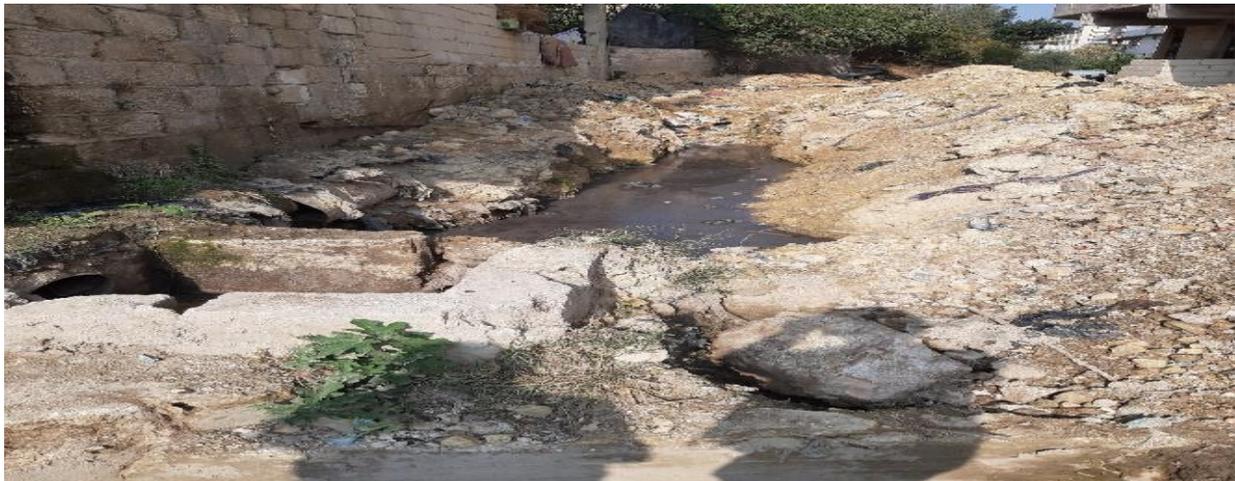
The following pictures show the status of sewage in Al-Marjah neighborhood.

In one of the cases in Al-Marjah neighborhood we visited, our field team noticed that the sewage lines surrounding or passing next to the patient's house were clearly damaged and uncovered, as the wastewater drains to the ground and spreads near the houses of the residents there .

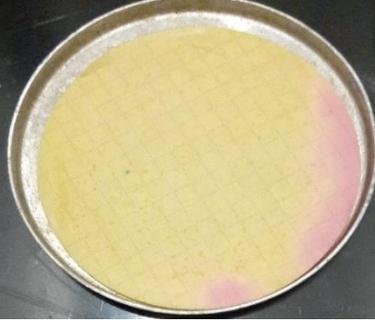
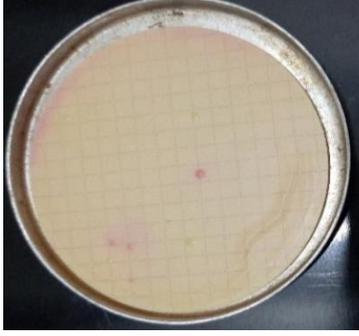
1. **A water sample from a patient's house in Al-Marjah neighborhood (a positive cholera case).**

7.3	6.5 - 8.5	pH الرقم الهيدروجيني
	C°	Temperature حرارة المياه
1.11	5 NTU	Turbidity العكارة
461	1200 ppm	TDS الأملاح الكلية المنحلة
640	1500 µs/cm	Conductivity الناقلية الكهربائية
Bacteriological Test التحليل الجرثومي للمياه		
The Result النتيجة	Unite الواحدة	Test التحليل
	PPM	FRC الكلور الحر المتبقي
6	Cfu/100 ml مستعمرة/100 مل	Coliforms Total تعداد الكولونيئات
50	Cfu/100 ml مستعمرة/100 مل	E.Coli (44 °C) تعداد الإشيريشيا كولاي
Sample Culture Photos صور الزرع الجرثومي للعينات		
Notes ملاحظات	at 37 C°	at 44 C°

Test Result النتيجة الإجمالية		
Result The النتيجة	Test التحليل	
Safe To Drink صالح للشرب	نتيجة التحليل الفيزيائي للمياه Physical Test Result of	
	نتيجة التحليل الكيميائي للمياه Chemical Test Result of	
Not Safe To Drink غير صالح للشرب	نتيجة التحليل الجرثومي للمياه Biological Test Result of	
	حالة منظومة التعقيم Chlorination Status

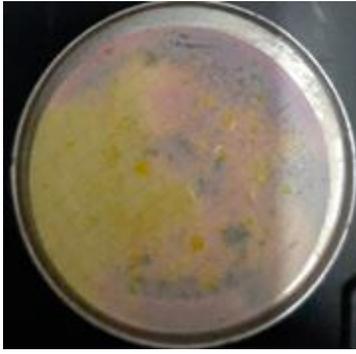
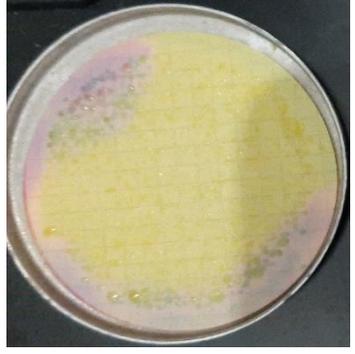
2. A water sample from a patient's house in Al-Nabaa neighborhood (a positive cholera case).

7.3	6.5 - 8.5	الرقم الهيدروجيني pH
	C°	حرارة المياه Temperature
1.88	5 NTU	العكارة Turbidity
427	1200 ppm	الأملاح الكلية المنحلة TDS
600	1500 µs/cm	النقلية الكهربائية Conductivity
التحليل الجرثومي للمياه Bacteriological Test		
The Result النتيجة	الواحدة Unite	التحليل Test
	PPM	الكولور الحر المتبقي FRC
250	Cfu/100 ml مستعمرة/100 مل	تعداد الكولونيات Coliforms Total
250	Cfu/100 ml مستعمرة/100 مل	تعداد الأشيرشيا كولاي E.Coli (°C 44)

Test Result النتيجة الإجمالية		
Result The النتيجة	Test التحليل	
Safe To Drink صالح للشرب	Physical Test Result of المياه التحليل الفيزيائي للمياه	
	Chemical Test Result of المياه التحليل الكيميائي للمياه	
Not Safe To Drink غير صالح للشرب	Biological Test Result of المياه التحليل الجرثومي للمياه	
	Chlorination Status حالة منظومة التعقيم

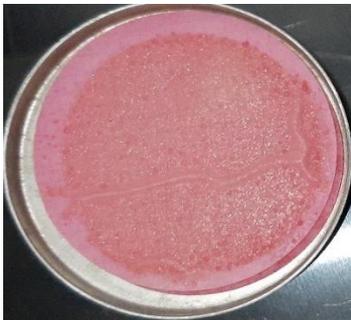
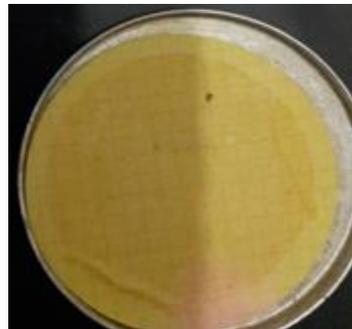
### 3. A sample of water from soaked vegetables

6.5 - 8.5	pH الرقم الهيدروجيني
	C°	Temperature حرارة المياه
	5 NTU	Turbidity العكارة
	1200 ppm	TDS الأملاح الكلية المنحلة
	1500 µs/cm	Conductivity الناقلية الكهربائية
Bacteriological Test التحليل الجرثومي للمياه		
The Result النتيجة	Unite الوحدة	Test التحليل
0	PPM	FRC الكلور الحر المتبقي
20	Cfu/100 ml مستعمرة/100 مل	Coliforms Total تعداد الكولونيئات
9	Cfu/100 ml مستعمرة/100 مل	E.Coli (°C 44) تعداد الإشريشيا كولاي
Sample Culture Photos صور الزرع الجرثومي للعينات		
Notes ملاحظات	at 37 C°	at 44 C°
تم نقع بعض الخضراوات اخذت من حارم في مياه ثم تم تحليل هذه المياه

Test Result النتيجة الإجمالية		
Result The النتيجة	Test التحليل	
Safe To Drink صالح للشرب	نتيجة التحليل الفيزيائي للمياه Physical Test Result of	
	نتيجة التحليل الكيميائي للمياه Chemical Test Result of	
Not Safe To Drink غير صالح للشرب	نتيجة التحليل الجرثومي للمياه Biological Test Result of	
	Chlorination Status حالة منظومة التعقيم

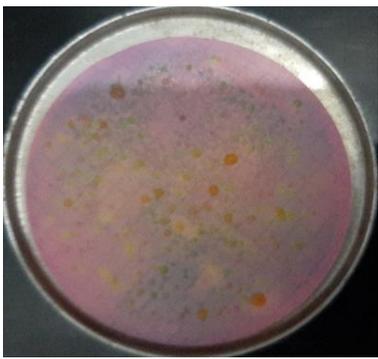
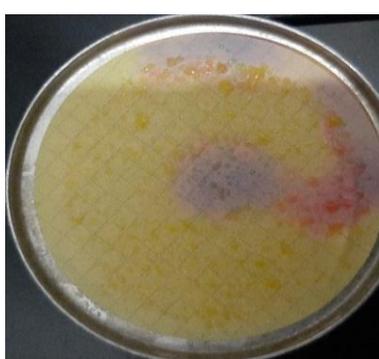
4. Water sample was taken from the spring

7.2	6.5 - 8.5	الرقم الهيدروجيني pH
	C°	حرارة المياه Temperature
0.76	5 NTU	العكارة Turbidity
458	1200 ppm	الأملاح الكلية المنحلة TDS
640	1500 µs/cm	الناقلية الكهربائية Conductivity
التحليل الجرثومي للمياه Bacteriological Test		
The Result النتيجة	الواحدة Unite	التحليل Test
	PPM	الكولور الحر المتبقي FRC
200	Cfu/100 ml مستعمرة/100 مل	Coliforms Total تعداد الكولونييات
200	Cfu/100 ml مستعمرة/100 مل	E.Coli (°C 44) تعداد الإشريشيا كولاي
صور الزرع الجرثومي للعينات Sample Culture Photos

Result The النتيجة	Test التحليل	
Safe To Drink صالح للشرب	Physical Test Result of التحليل الفيزيائي للمياه للمياه	
	Chemical Test Result of التحليل الكيميائي للمياه للمياه	
Not Safe To Drink غير صالح للشرب	Biological Test Result of التحليل الجرثومي للمياه للمياه	
	Chlorination Status حالة منظومة التعقيم

1. Immediately stop using spring water for drinking purposes, irrigation, and other domestic uses such as bathing, dishwashing, and washing vegetables and fruits knowing that the number of confirmed cases in Harim has increased clearly because of non-stopping using the polluted spring water.
